Long Duration Exposure Facility

Systems Special Investigation Group

Interim Report

January 1991

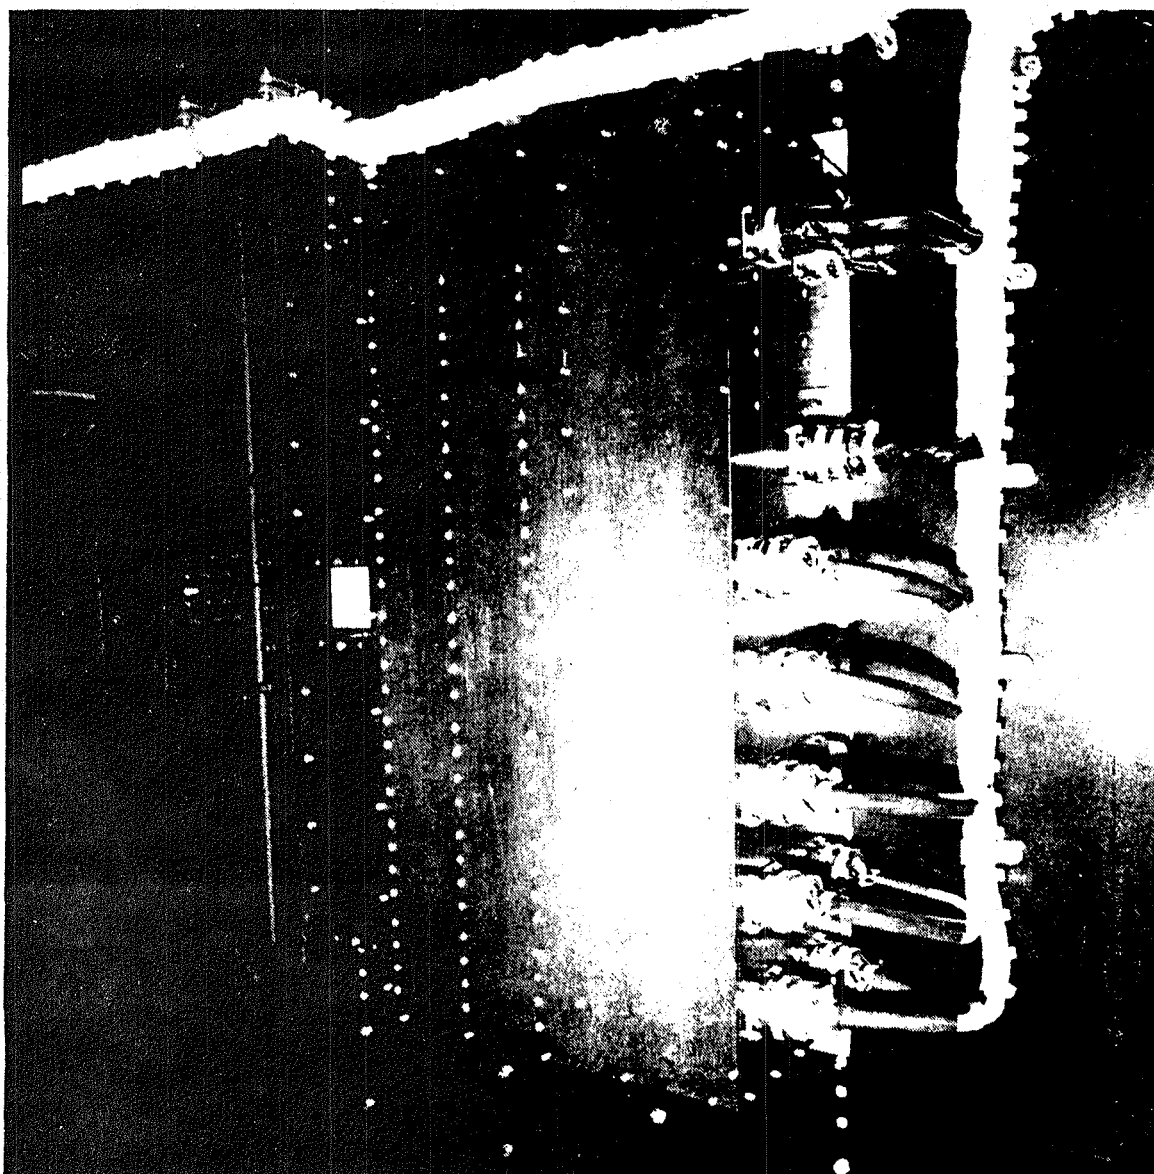
THE EIS CONTROL BOX

The EIS control circuitry was housed in this aluminum enclosure, located on the interior structure of LDEF. It was protected from direct exposure to the exterior by the LDEF frame structure and the experiment trays. The cabling shown is typical of the LDEF wire harness construction, with extensive use of tie wraps and clamps to the frame. Visual status indicators were located on the right side of the box (not visible in photograph).

The EIS control box was examined internally at NASA Langley Research Center. This was the first LDEF electronic system examined in this manner, and serves at a reference point for future examinations of EPDS units and others. No degradation or significant anomalies were observed on any of the internal components or circuit cards. Minor anomalies, including debris from initial assembly and a loose connector clamp ring, were observed, but these would not have resulted in any degradation of performance. However, they do point to the importance of meticulous handling and cleaning of space hardware. Obviously, debris which was electrically conducting (not observed in EIS) could cause major problems while drifting during weightlessness.

- Internal inspection: no degradation
- Loose clamp ring on connector
- Failed status indicator: probable particle-induced intermittency, detectable by testing at low voltage, minimum pulse width

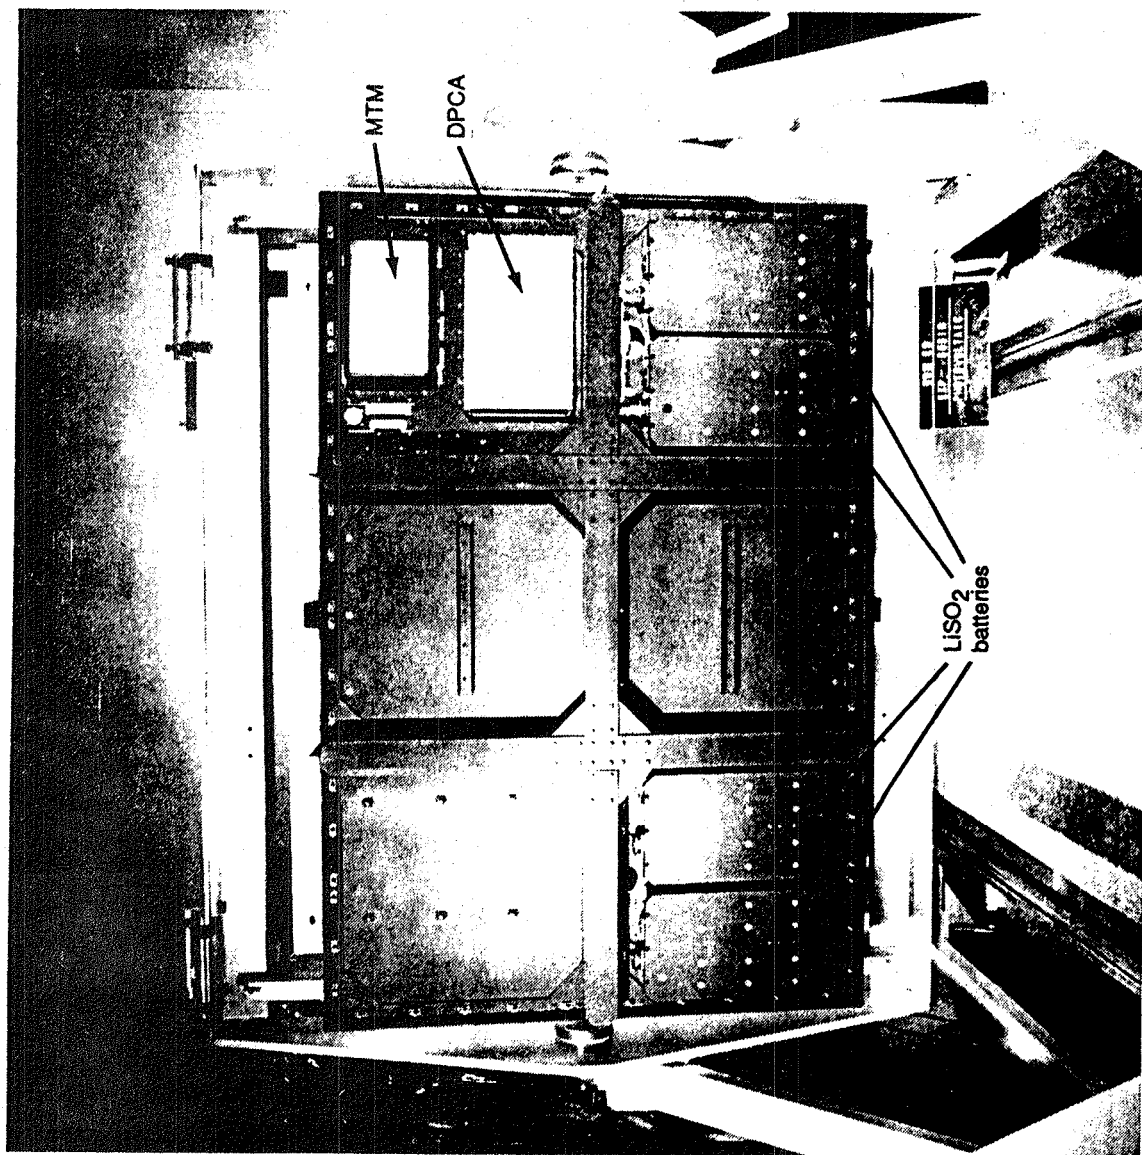
TYPICAL EPDS MOUNTING

The principal EPDS components are shown in the upper right corner of this tray, consisting of the DPCA (Data Processor and Control Assembly) and the MTM (Magnetic Tape Module). These, together with associated batteries, were mounted on a one-third-tray size plate, with the space side (hidden) protected with an aluminum and fiberglass shield.

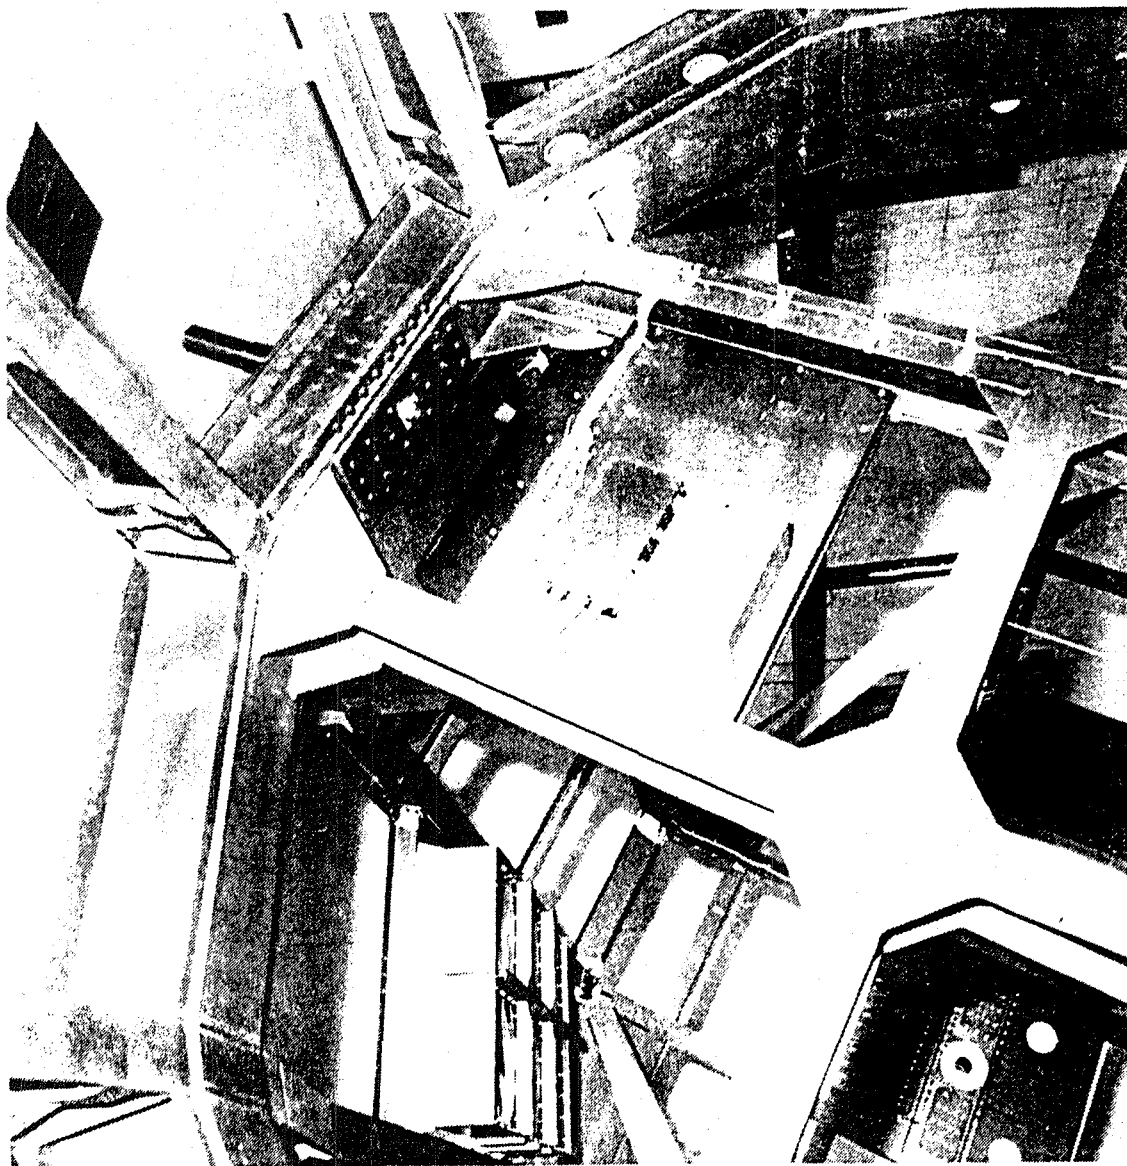
TYPICAL WIRE HARNESS INSTALLATION

Special clamps were fabricated to provide attachment points on the LDEF frame without drilling holes into structural members. The harness made numerous bends over structural members, with extensive use of clamps and Teflon jacketing for protection.

The entire wire harness performed flawlessly. No deterioration of any components or degradation of electrical properties was observed. It should be noted that the wire harness was not directly exposed to the external environment (notably atomic oxygen), being protected by the experiment trays (metal) and the LDEF frame structure.

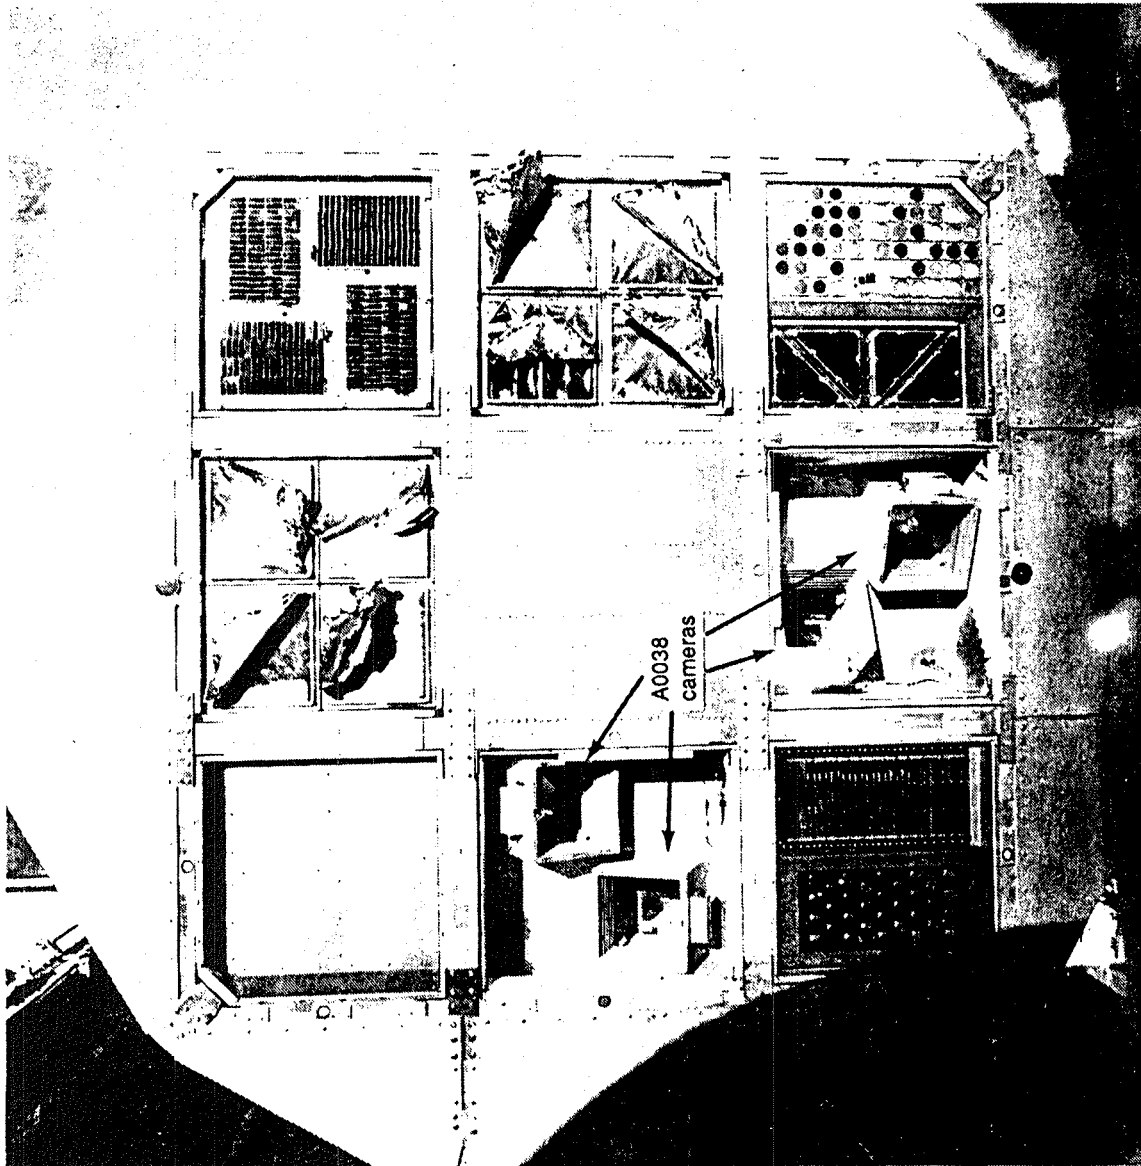
SPACE END OF LDEF, WITH TWO IGE TRAYS PLUS OTHERS

This in-orbit photo shows two of the four IGE trays, each containing two cameras. The IGE cameras (angled box enclosures) contained the flat foil plates, each hinged along one bottom edge and intended to rotate toward the front of the camera box, stopping when parallel to the box sides and out of the direct path of gas atoms traveling through the camera to the next foil in the sequence.

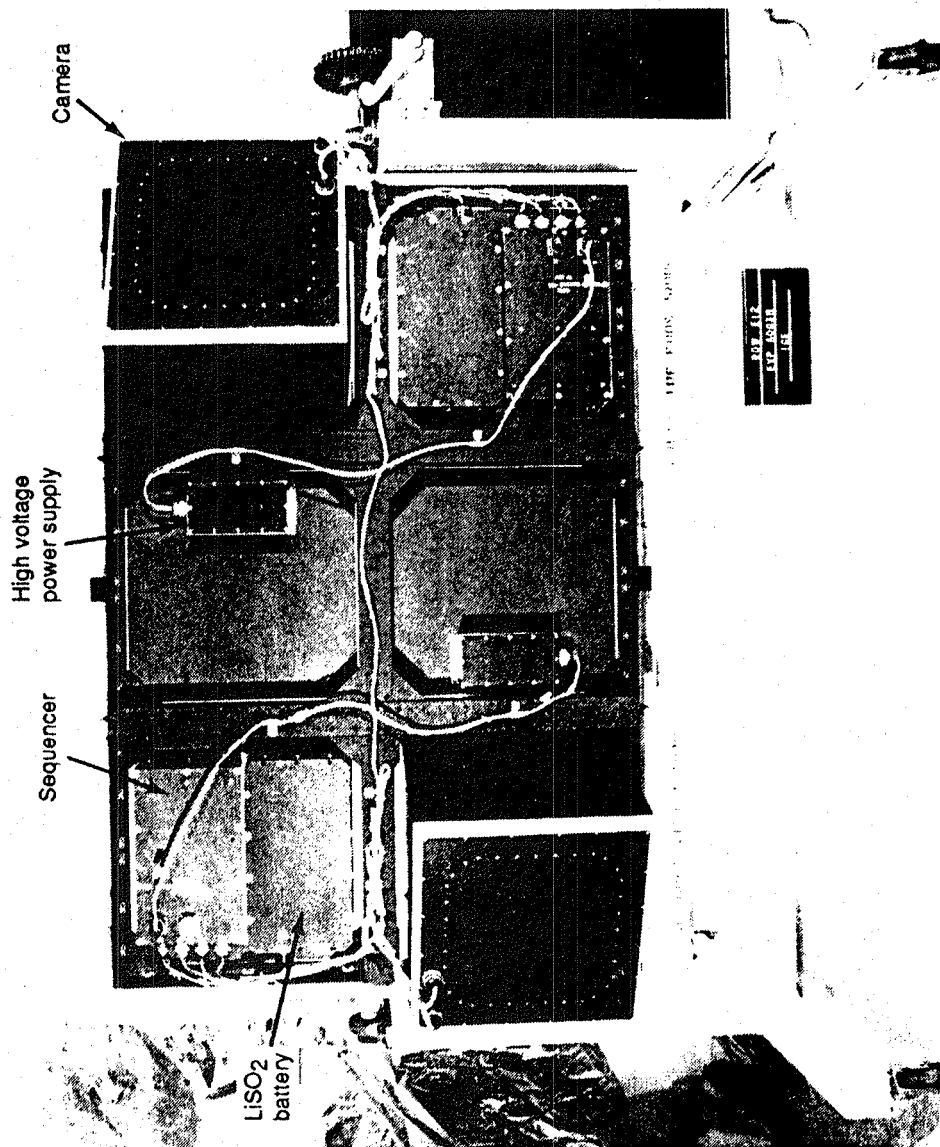
REAR OF ONE OF THE IGE TRAYS

Shown are the batteries and sequencers (diagonal corners), and the backs of two cameras with associated high voltage power supplies.

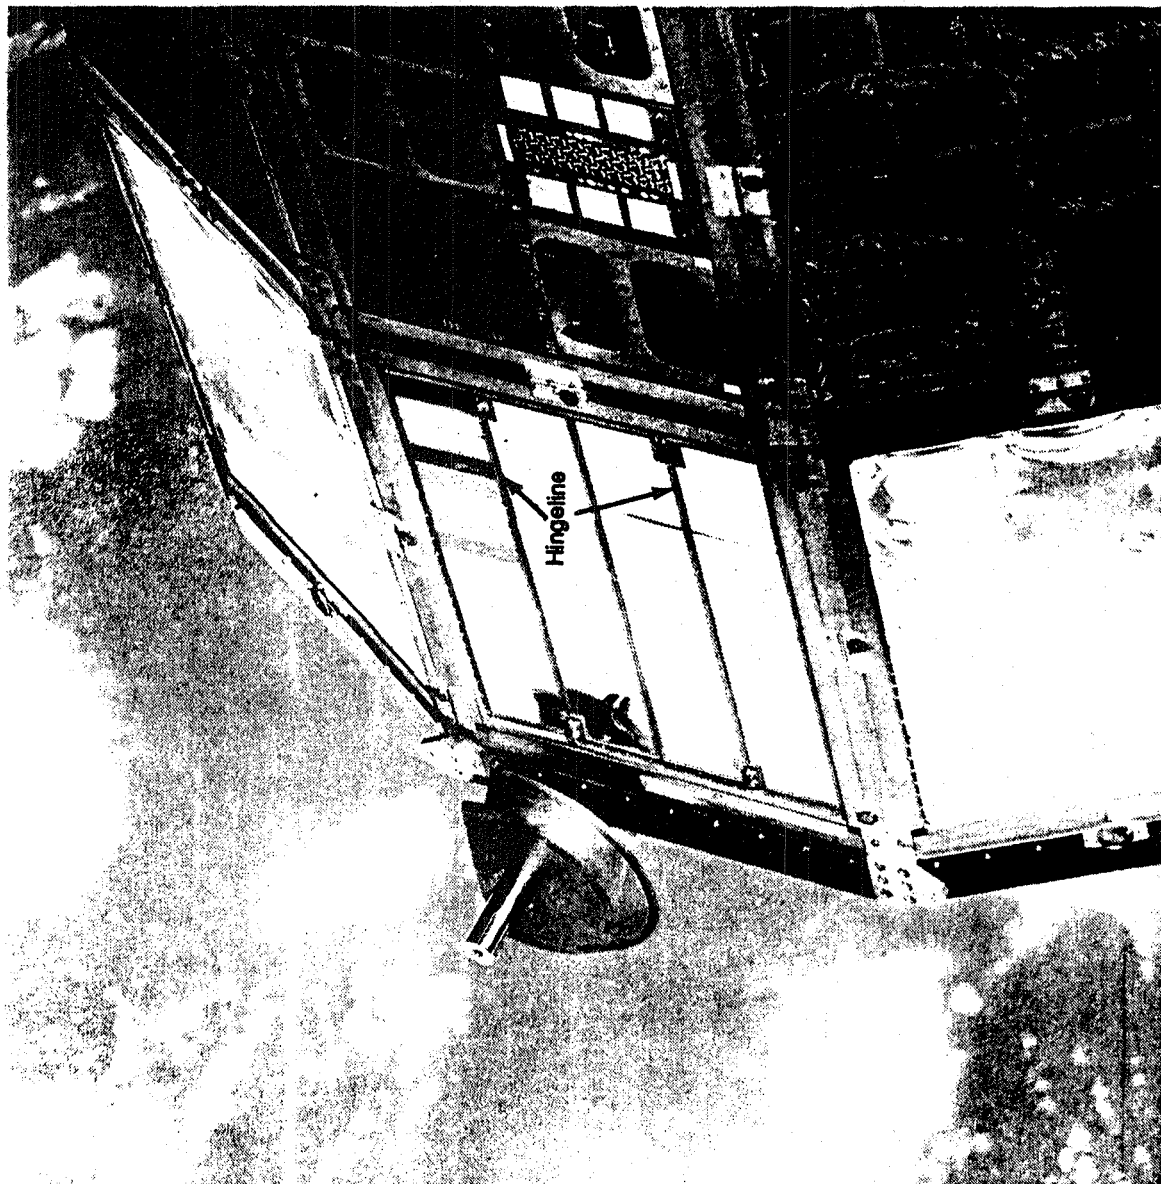
A0187-1 TRAY IN ORBIT, WITH CLAMSHELLS OPEN

The two rows of four foils are each hinged along their longitudinal axis, and would have folded together prior to recovery if the intended sequence had been followed.

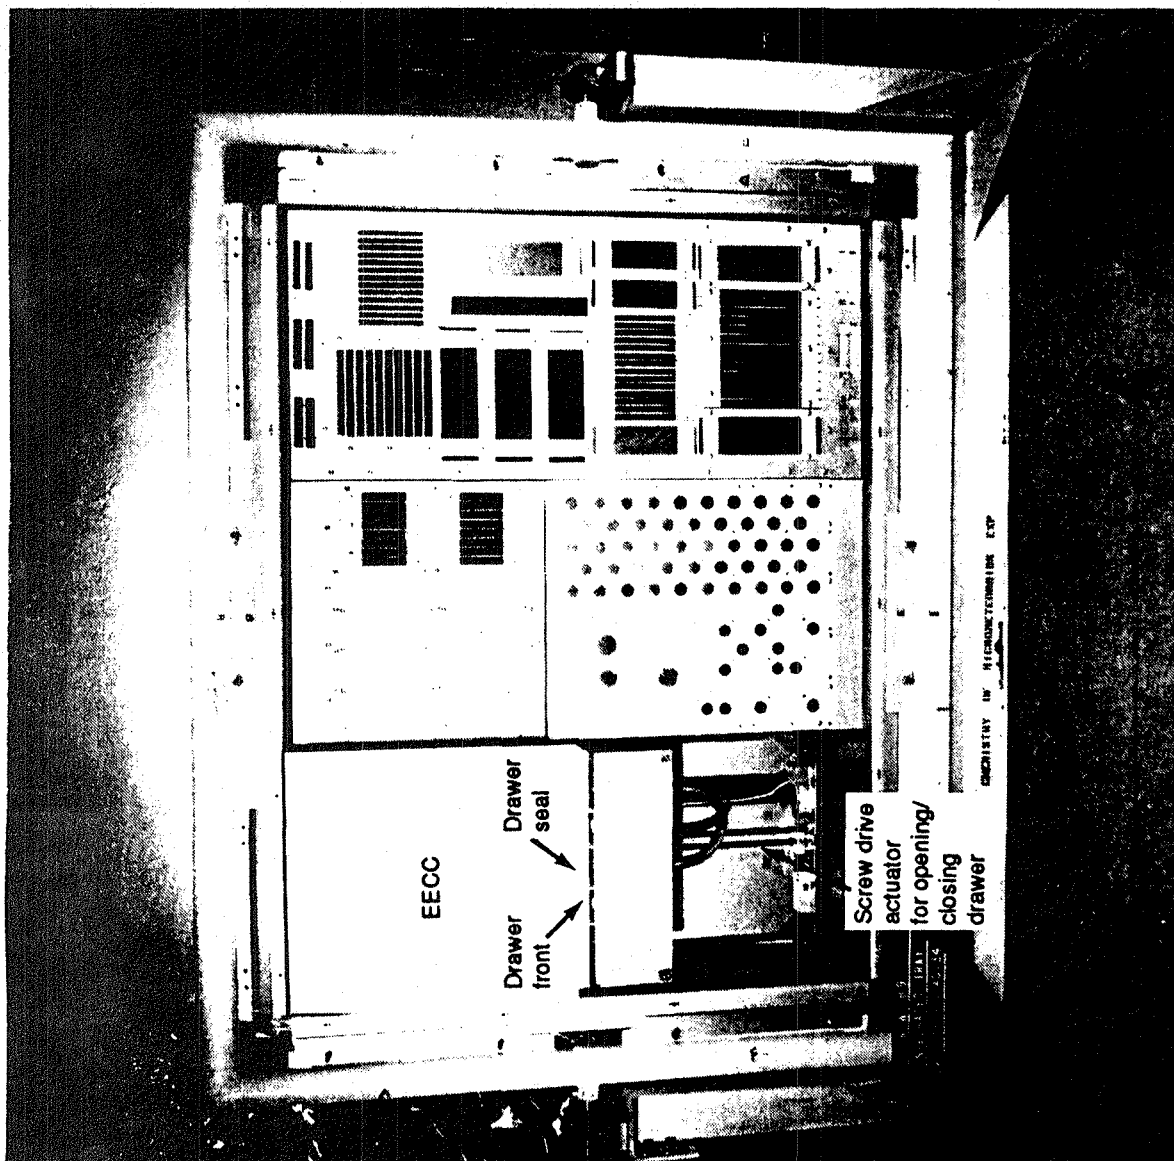
Photograph shows the EECC as mounted in an experiment tray. Drawer actuator is noted. Radiative heat shields cover the canister and drawer front to control the content's thermal exposure and protect the drawer sealing mechanisms.

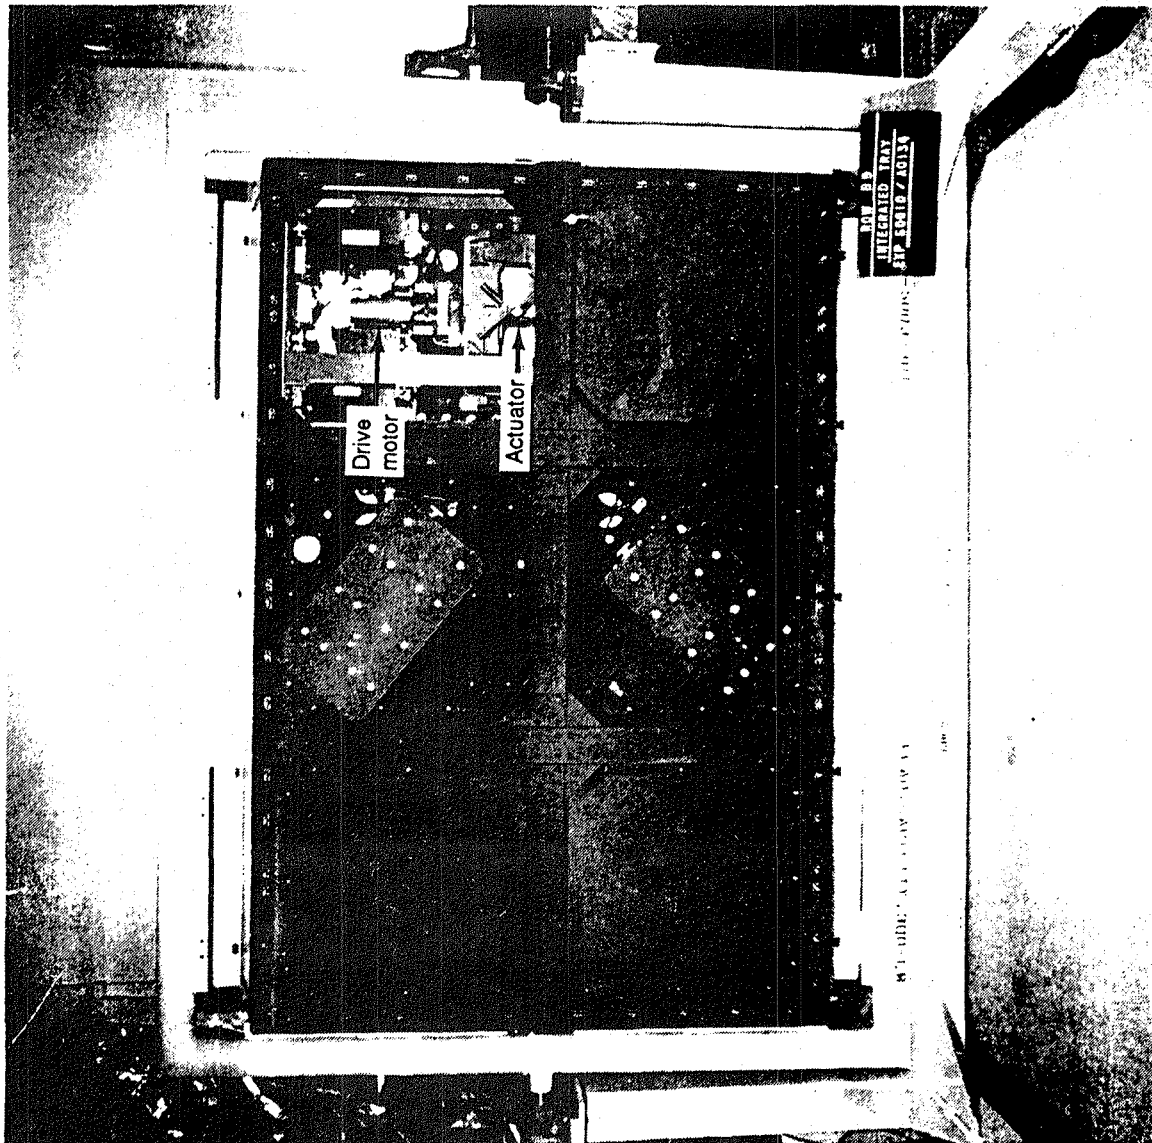
Photograph shows backside of EECC as mounted in an experiment tray.
Drawer actuator and drive motor is noted.

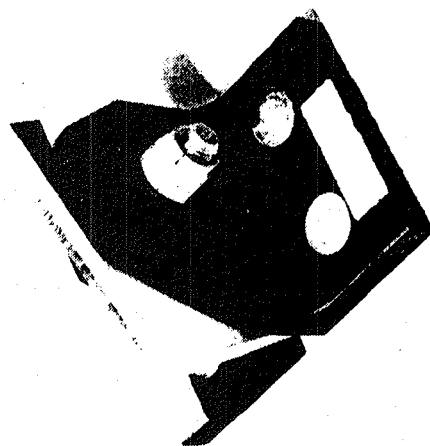
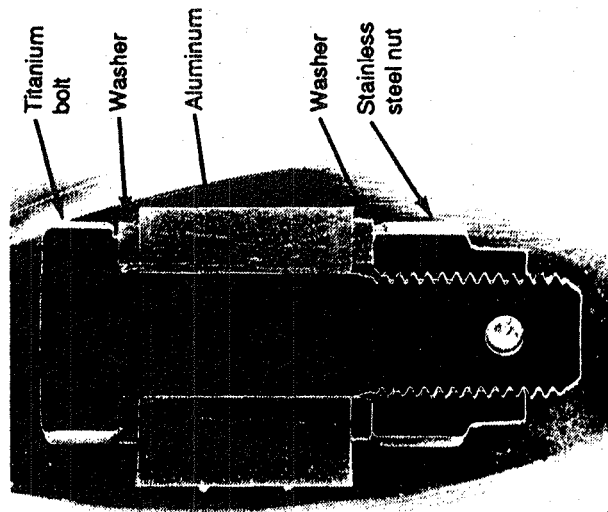
An unassembled, undisturbed, and as-flown titanium intercoastal fastener (LEFT) was cross-sectioned (RIGHT) to investigate the possibility of cold-welding without the complications of removal effects. The thread faying surfaces and bolt shank/aluminum plate interfaces were examined for indications of cold- (or micro-) welding. Close-ups of the areas of interest are shown in the following figures.

This fastener assembly was cross-sectioned because of its availability, not because we had evidence that cold welding had occurred.

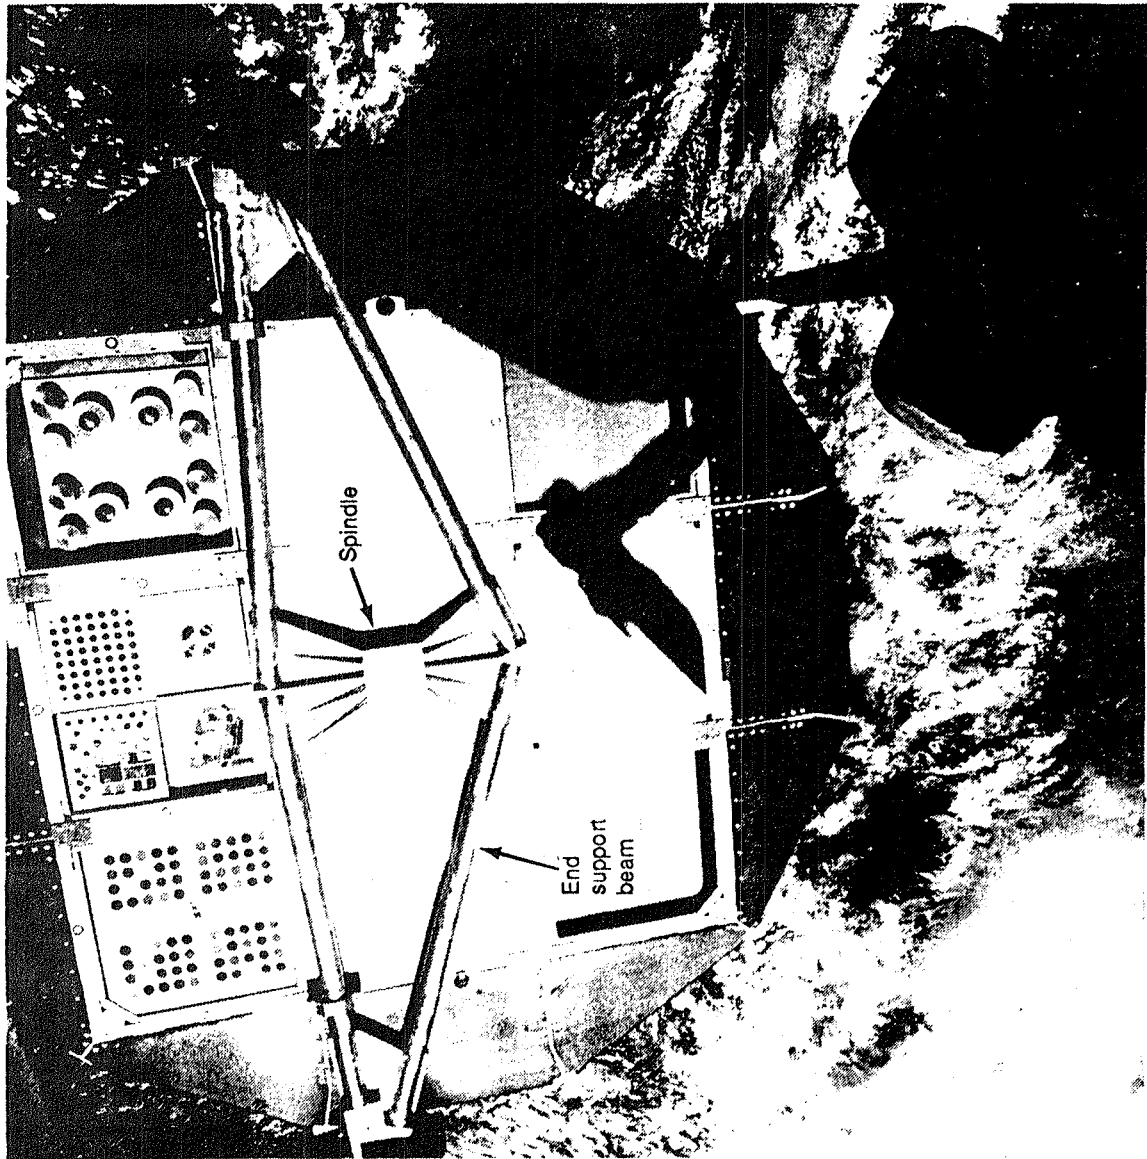
End Support Beam

During post-flight removal, no difficulties were encountered during the initial axial displacement of the ESB from the spindle. However, after approximately one inch of axial displacement had been accomplished, a great deal of difficulty was encountered.

Review of the video documenting the removal of the ESB strongly indicated these difficulties and the resulting galling damage to the aluminum ESB bore were caused by alignment difficulties. The hoist installed to support the beam apparently caused it to cock and jam on the spindle as the beam was pulled off of the first spindle land. Uncontrolled and excessive rotation of the jammed ESB about the spindle in an attempt to further move it caused extensive galling damage on the inner bore of the ESB as seen in the following photograph.
